SILVER LAKE DAM

PHASE I INSPECTION REPORT NATIONAL DAM SAFETY PROGRAM

DE 00041

JUNE 1978

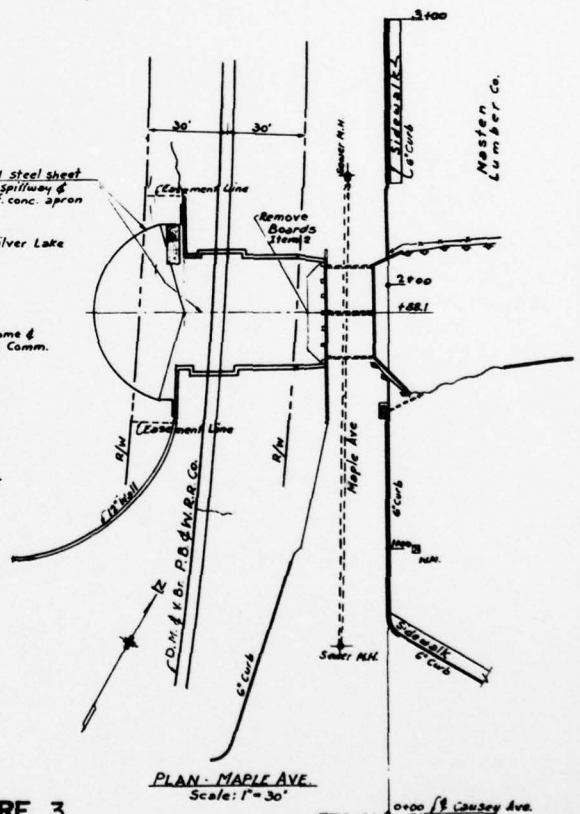
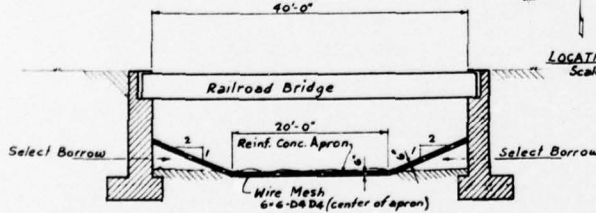
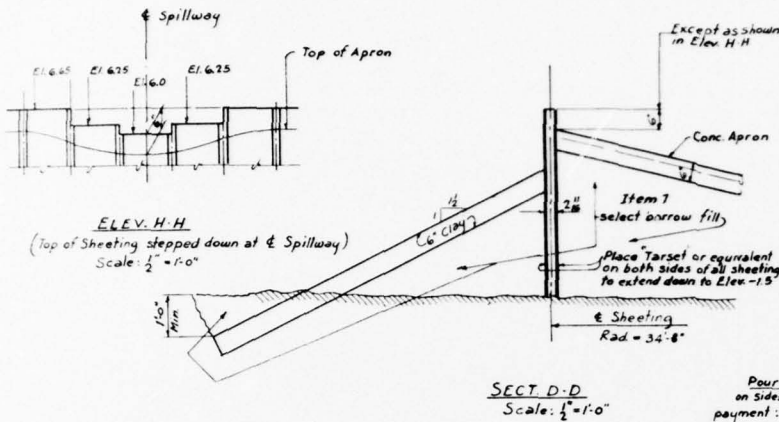
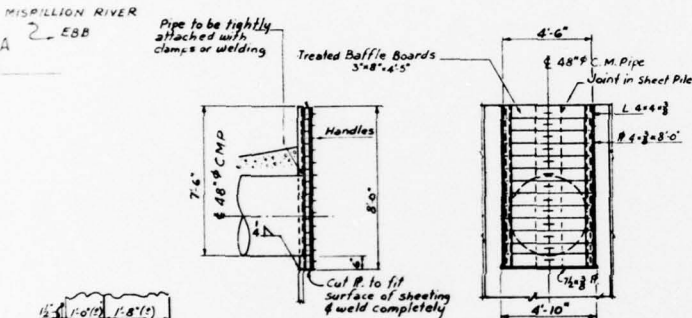
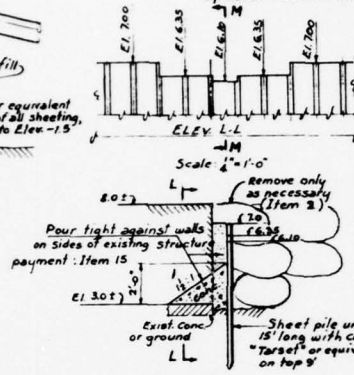
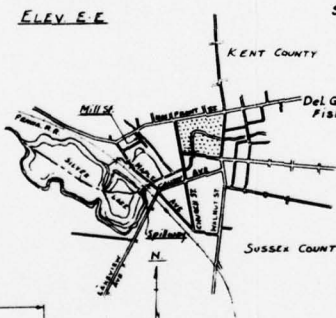
FIGURE 3

According to a design drawing (see Figure 3) provided by the Delaware Department of Natural Resources and Environmental Control (DDNREC), Division of Soil and Water Conservation, a sloping clay blanket rests against the upstream face of the vertical sheeting.

A design drawing was provided by the DDNREC, Division of Soil and Water and is reproduced herein as Figure 3.
